MEMORANDUM

Date: June 2, 2020
From: Mark Perry, Natural Resources Specialist
Subject: Redwood Falls SE Development Study Area
Keith Muetzel, City Administrator, City of Redwood Falls
BMI Project No.: S17121459

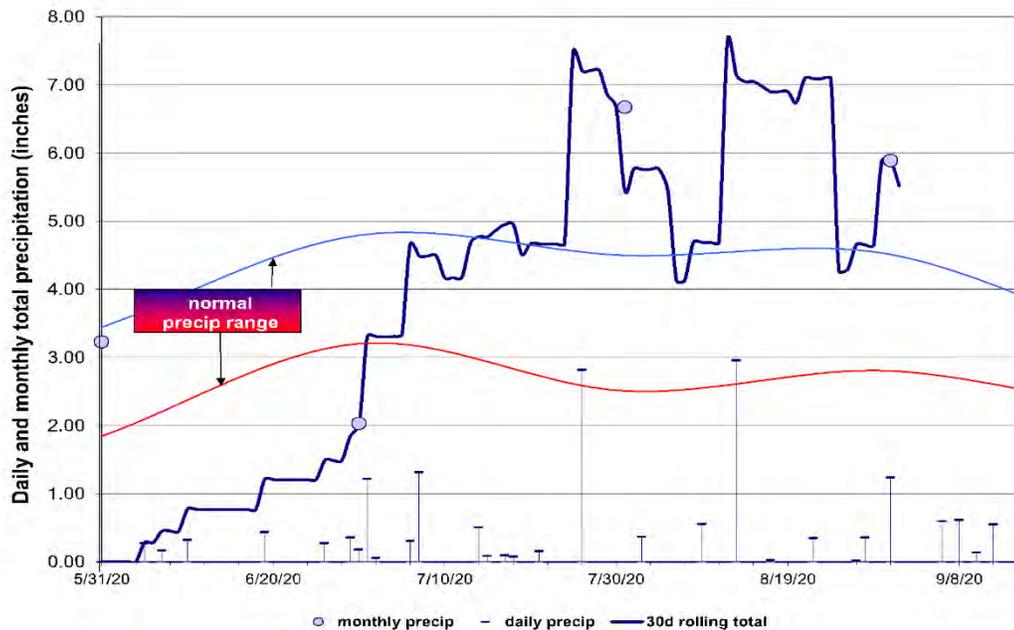
ANTECEDENT PRECIPITATION CONDITIONS

Antecedent precipitation was evaluated using a combination of the NRCS Method and the Rolling Totals Method. The analysis found that precipitation was well above average for the 60 days leading up to this investigation.

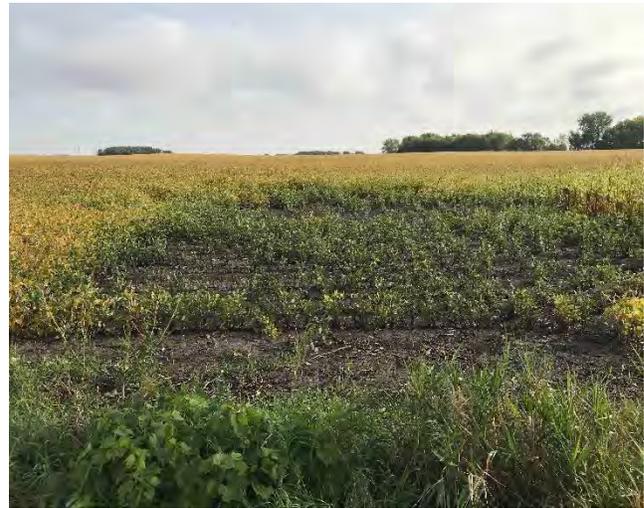
Wetland 8 lies within the lowest part of a depression in a drained cropland field. The level 1 delineation had indications of wet signatures 36% of the time in this depression. Other than this small depression, there appeared to be no crop stress even with higher than average precipitation the last two months. The sample transect was taken near the corn/soybean boundary.

View of Wetland 8, facing northeast, from TH 67

The field investigation found that the site has met all three wetland indicators and this wetland should be considered a of a palustrine emergent nonpersistent saturated (PEM2B) wetland. Based upon the level 1 study, the field is adequately drained in most years (64%). Several sample points were taken to determine the wetland boundary.

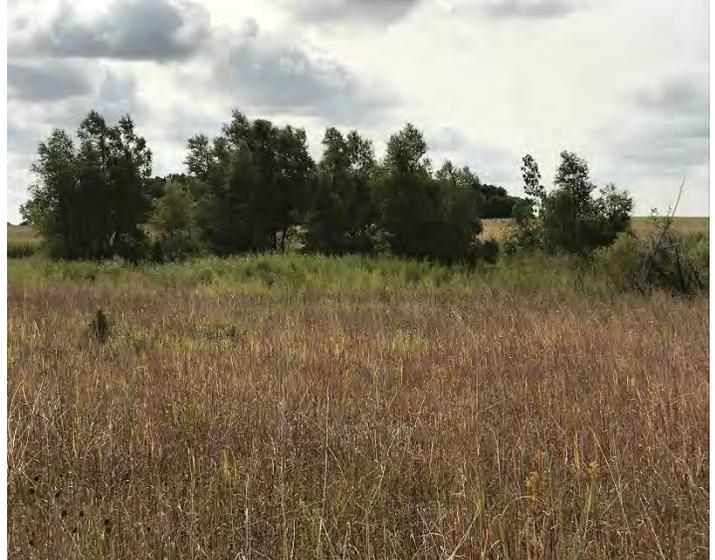
Wetland 12 is located approximately 1,800 feet east of CR 1 and 800 feet south of County Ditch 52 in what appears to be some type of set aside or prairie restoration area. Based upon soil survey and contour maps it appears that this basin may have been constructed.

View of Wetland 12, facing south.

The field investigation found that the site has met all three wetland indicators and this wetland should be considered a palustrine emergent scrub shrub seasonally flooded/saturated (PSS6E) wetland. Several sample points were taken to determine the wetland boundary.

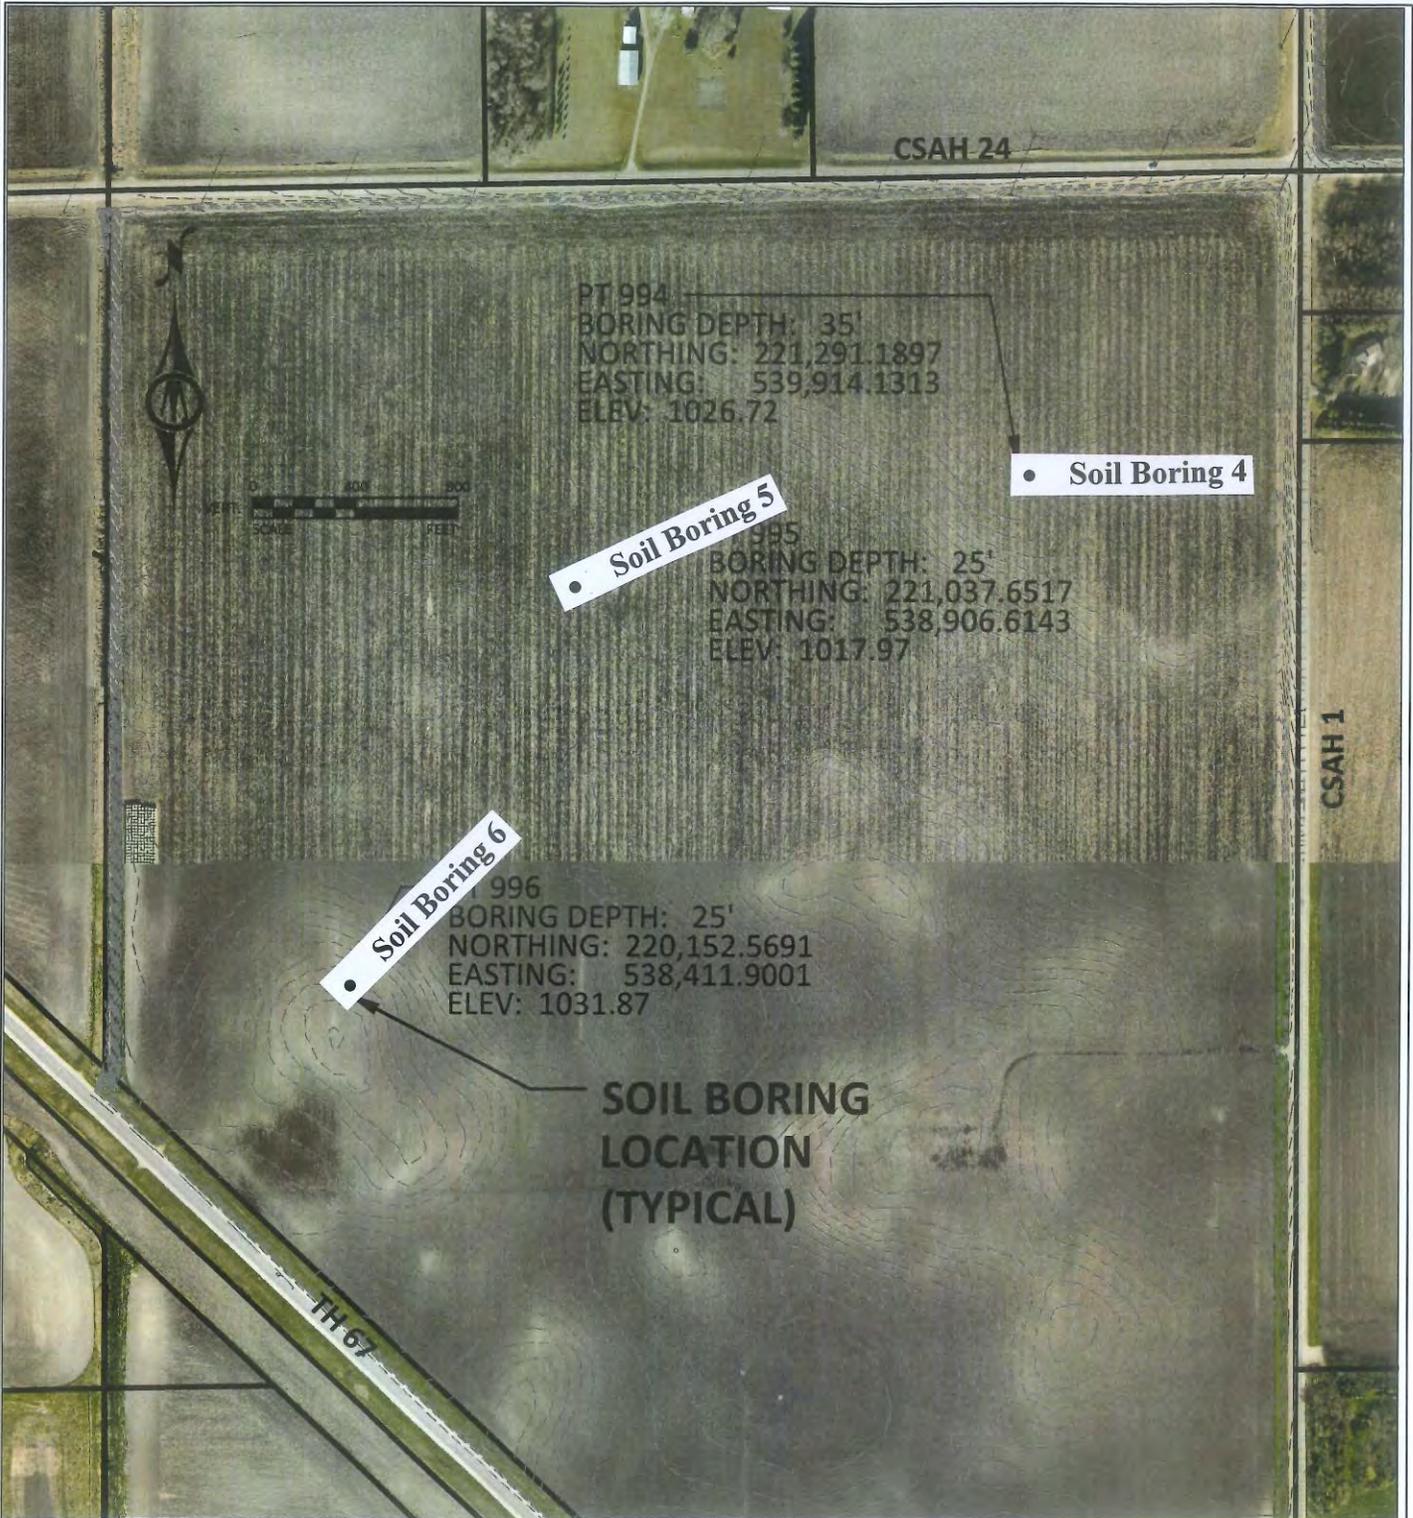
Figure: 2

The subsurface conditions at the site were explored by drilling and sampling three (3) standard penetration test borings. The locations of the borings appear on Figure 2, preceding the Subsurface Boring Logs in this appendix.

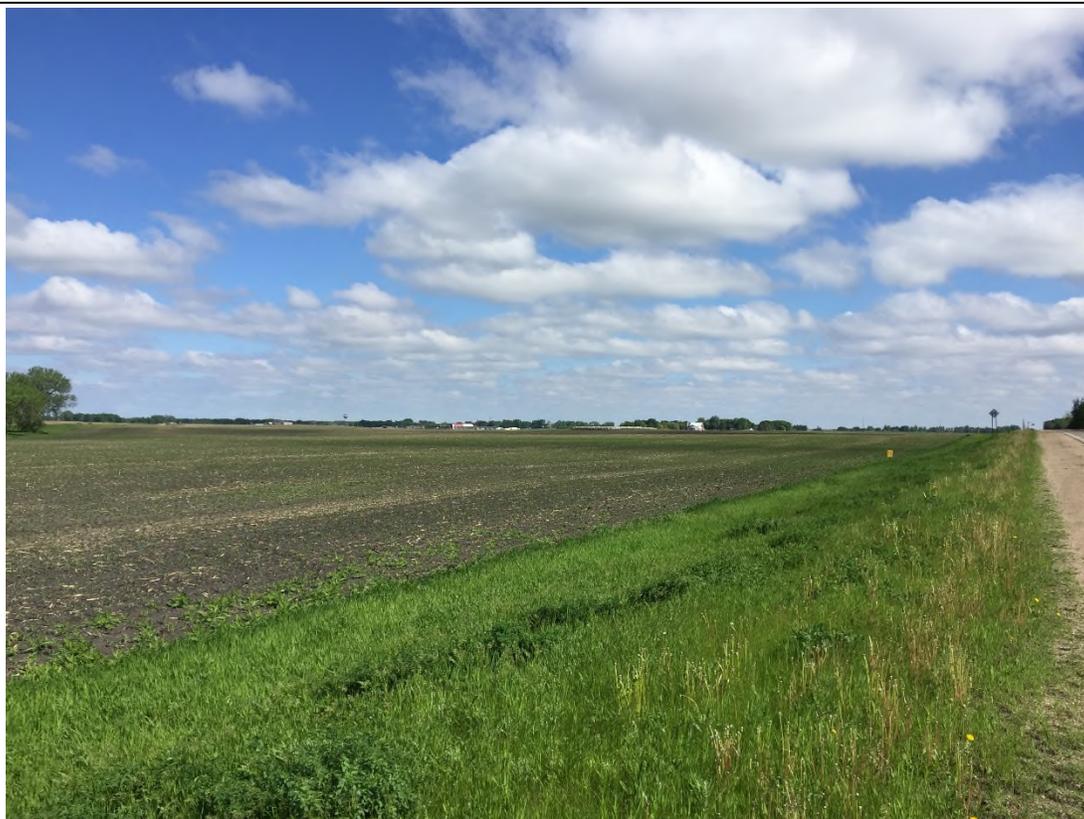
Photograph #1	Residential Development, Redwood Falls, MN	B2004585
Date:	May 29, 2020	BRAUN INTERTEC
Direction:	Northwest from CR 1 and Highway 67	
Subject:	Southwest parcel of Site

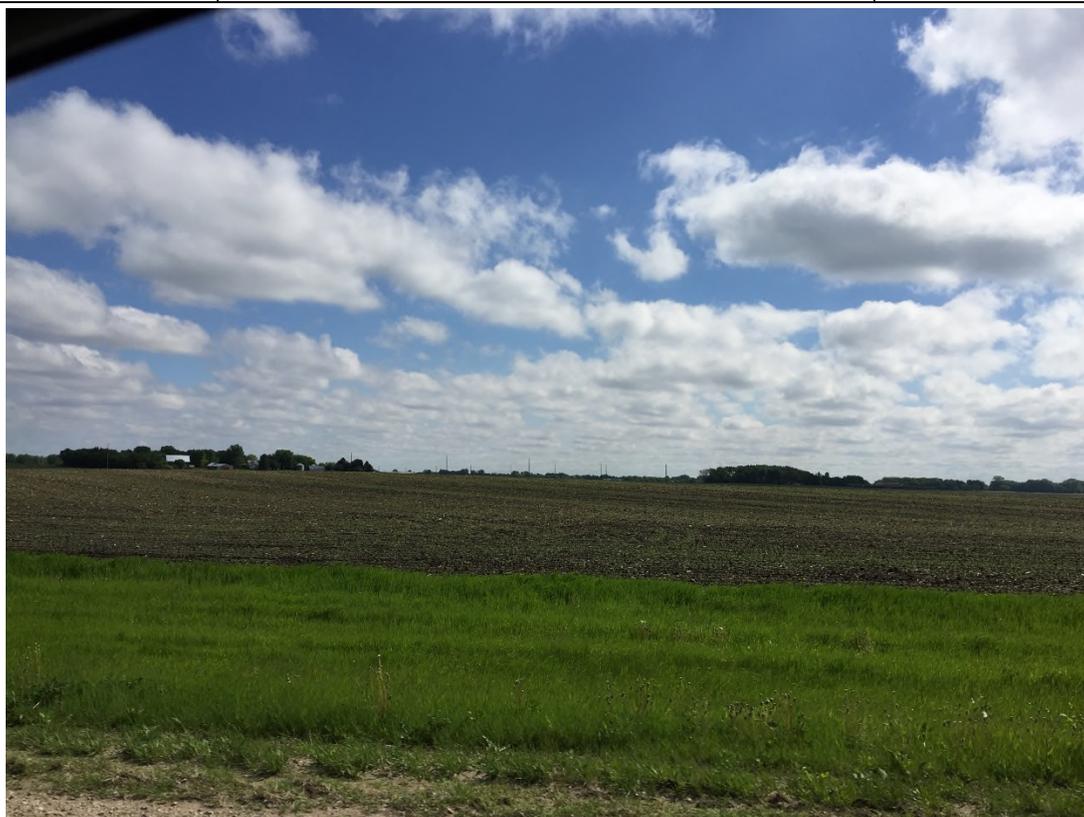
Photograph #2	Residential Development, Redwood Falls, MN	B2004585
Date:	May 29, 2020	BRAUN INTERTEC
Direction:	Northeast from Highway 67	
Subject:	Southwest parcel of Site

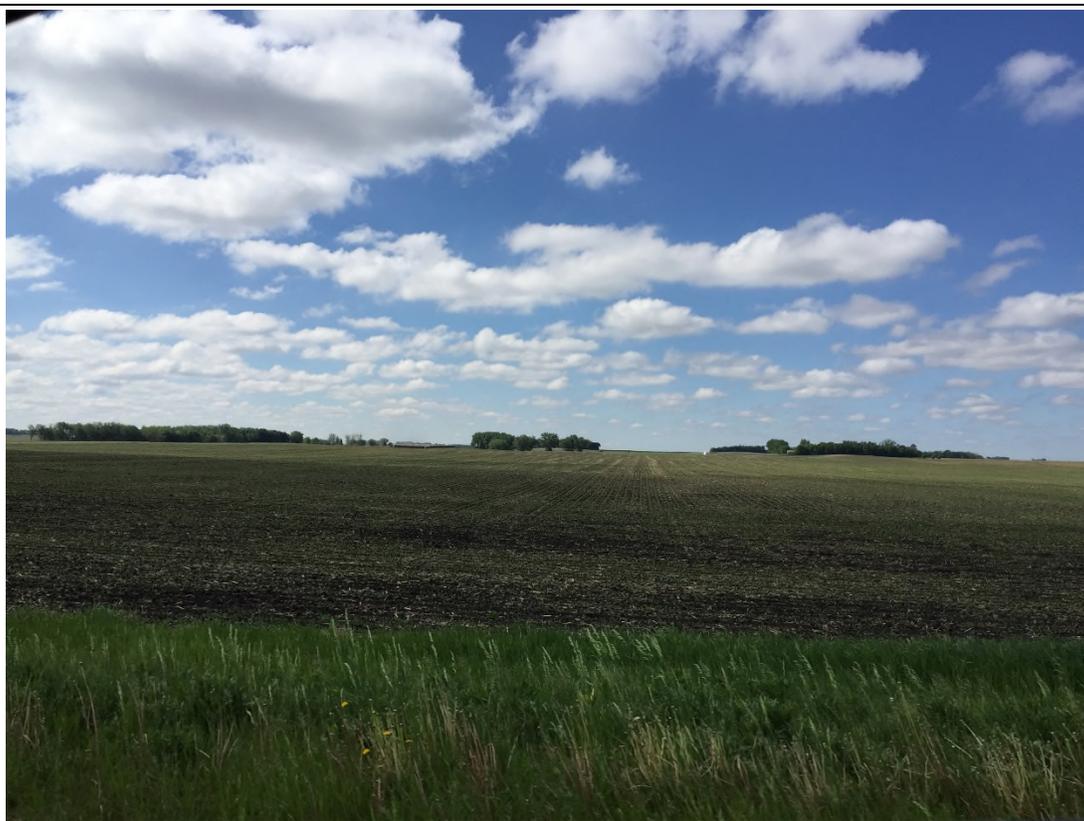
Photograph #3	Residential Development, Redwood Falls, MN	B2004585
Date:	May 29, 2020

Direction:	South from CR 24	
Subject:	Southwest parcel of Site

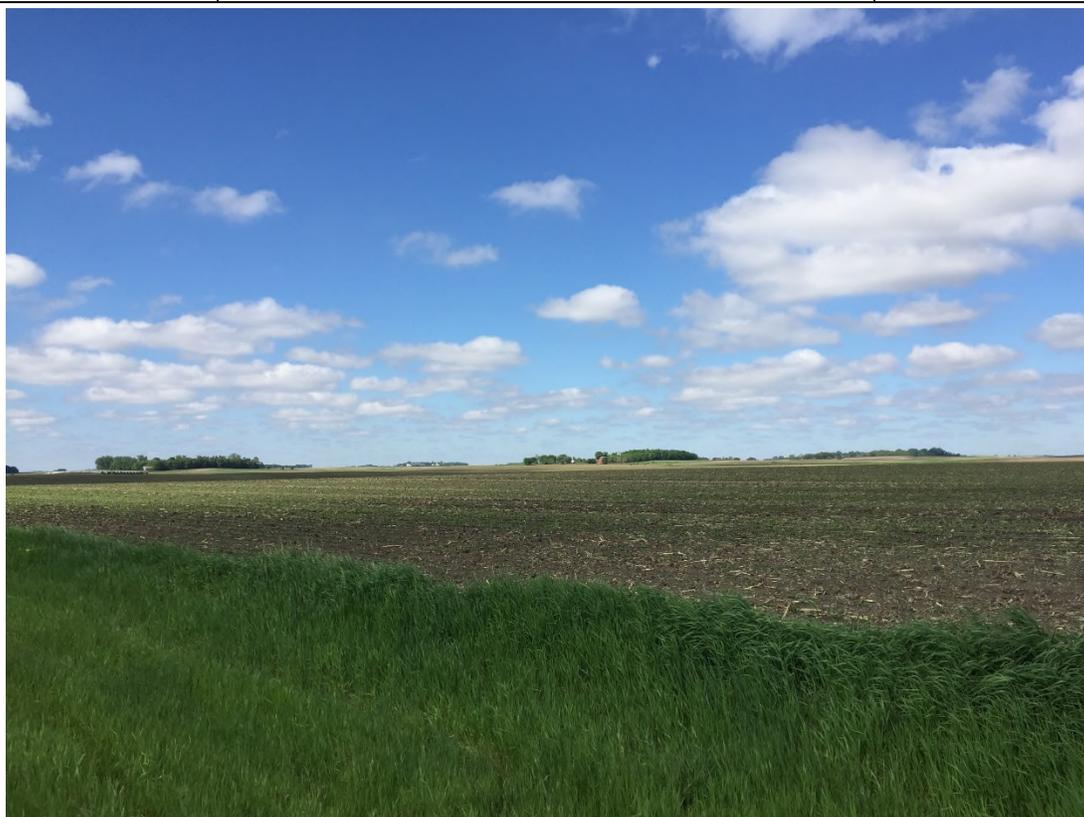
Photograph #4	Residential Development, Redwood Falls, MN	B2004585
Date:	May 29, 2020

Direction:	Southwest from CR 24 and CR 1	
Subject:	Southwest parcel of Site

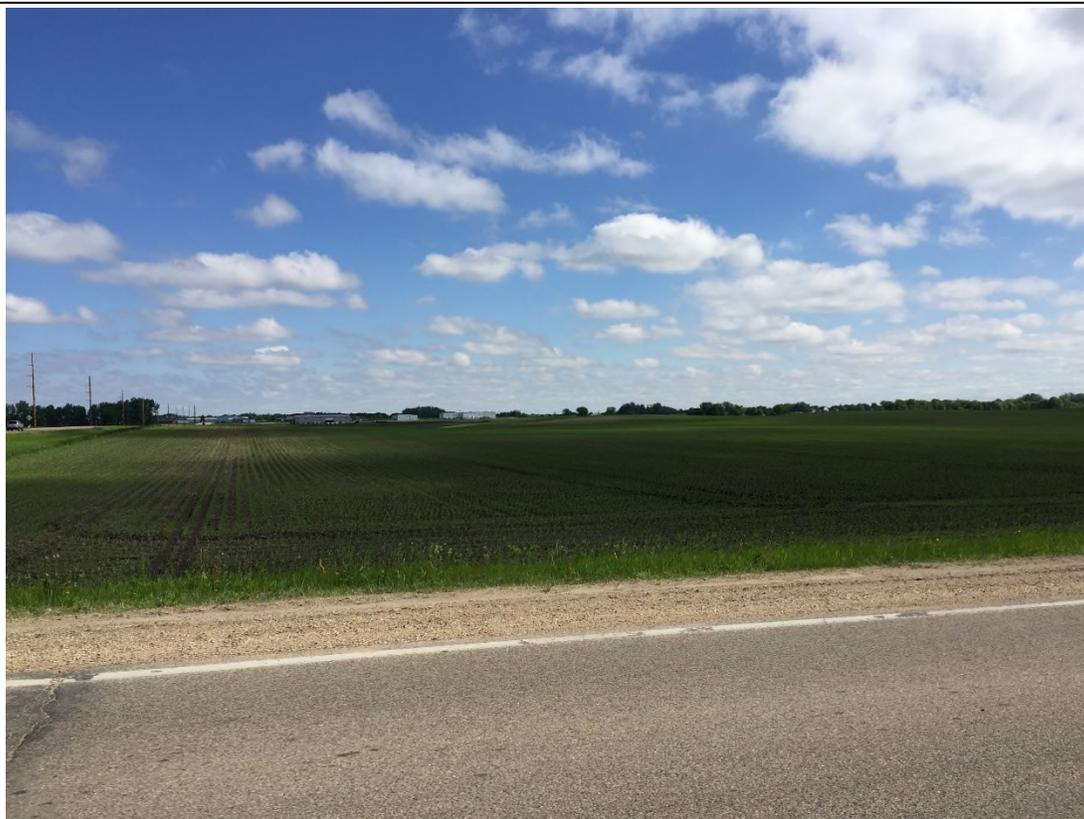
Photograph #5	Residential Development, Redwood Falls, MN	B2004585
Date:	May 29, 2020

Direction:	North from CR 24	
Subject:	West portion of northeast parcel of Site

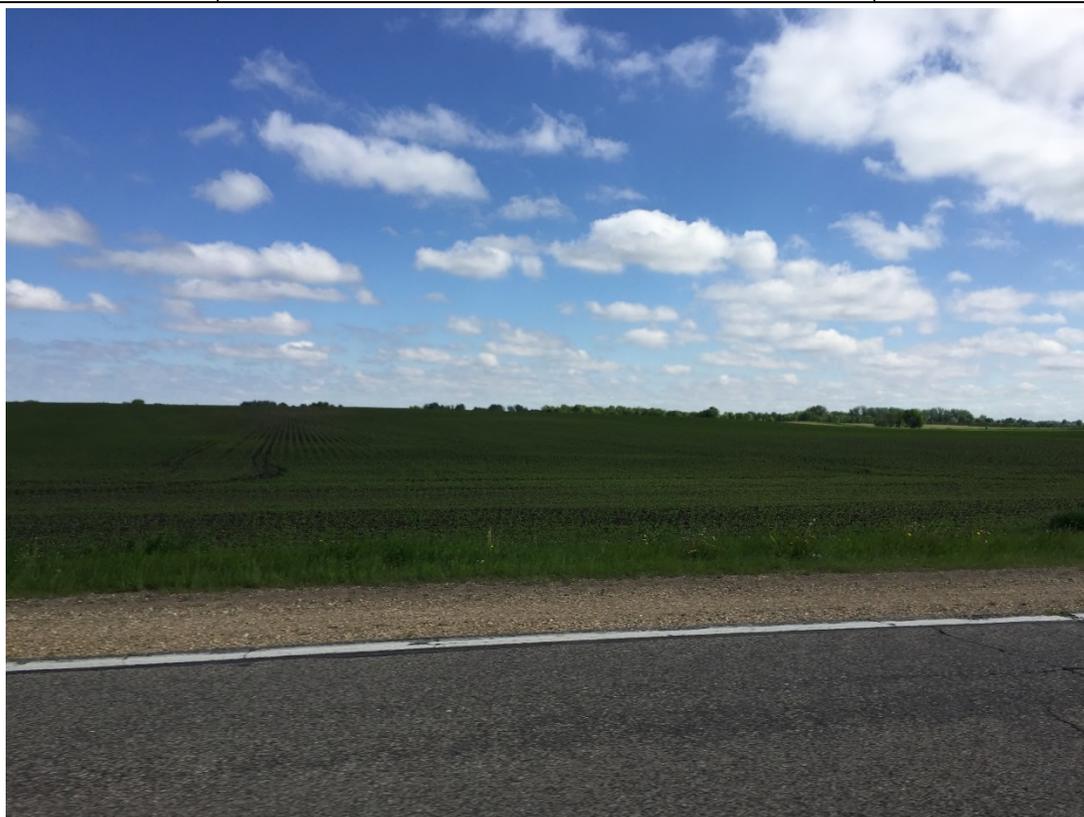
Photograph #6	Residential Development, Redwood Falls, MN	B2004585
Date:	May 29, 2020

Direction:	North from CR 24	
Subject:	East portion of northeast parcel of Site

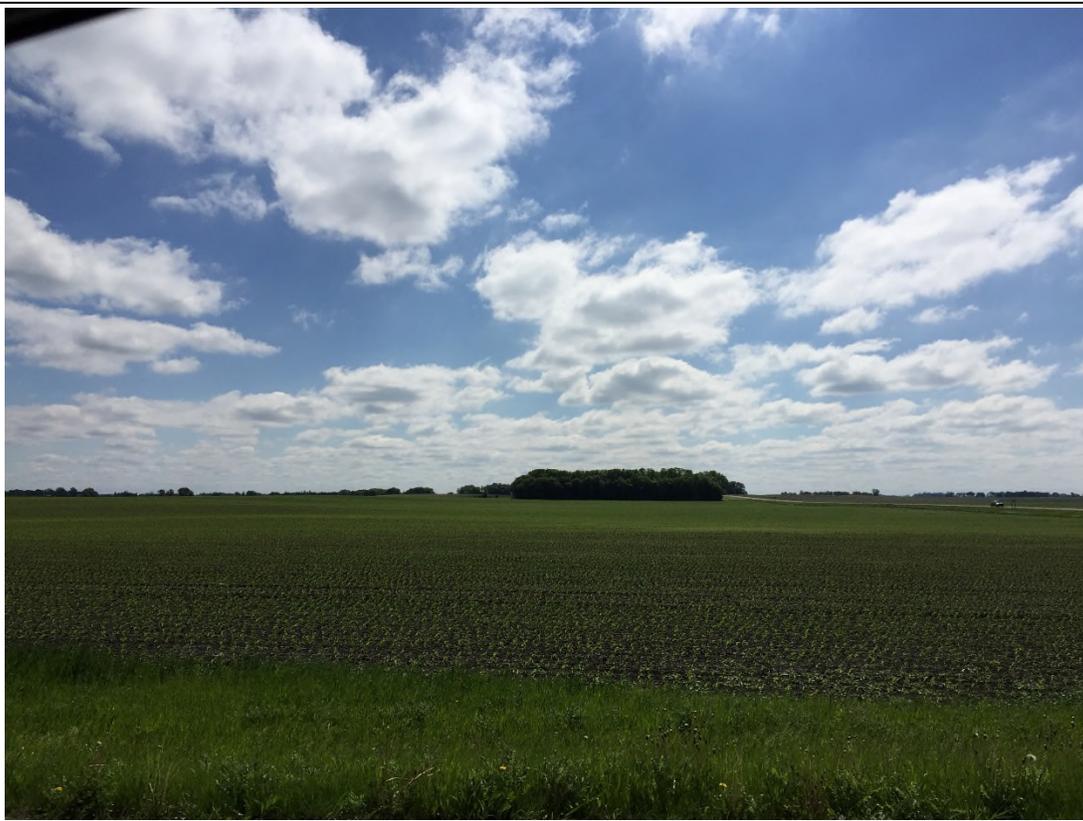
Photograph #7	Residential Development, Redwood Falls, MN	B2004585
Date:	May 29, 2020	BRAUN INTERTEC
Direction:	East from CR 1	
Subject:	South portion of northeast parcel of Site
